RES INSP 000001 /

/ 20 Nov 2019

Potable Water Reservoir Inspection

Reservoir Name

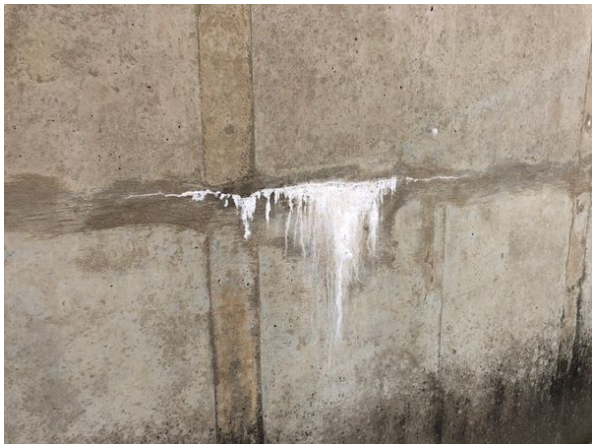
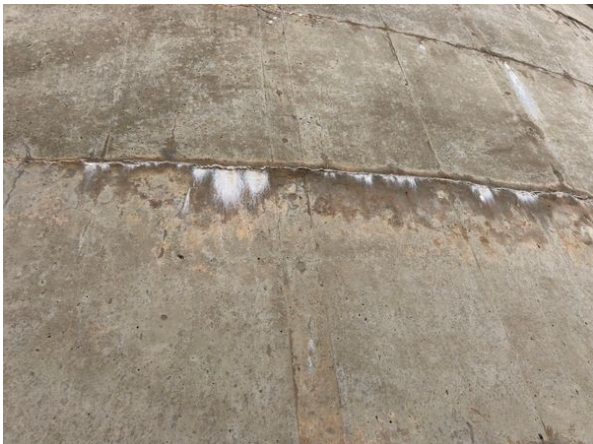
External wall condition	Good Condition
-------------------------	----------------

Some areas showing evidence of prior leaking of water

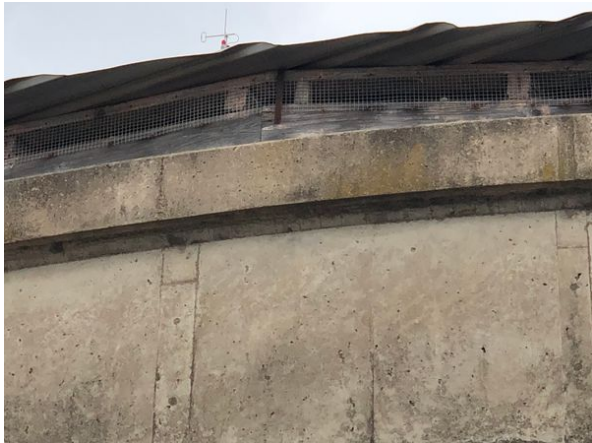
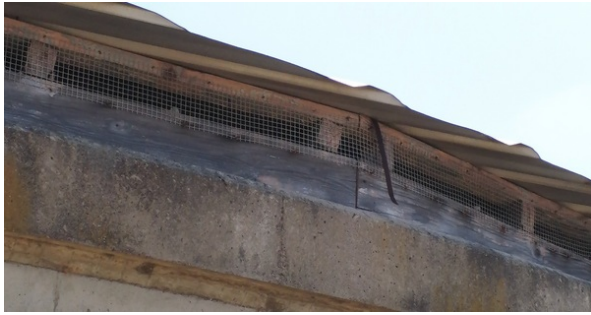
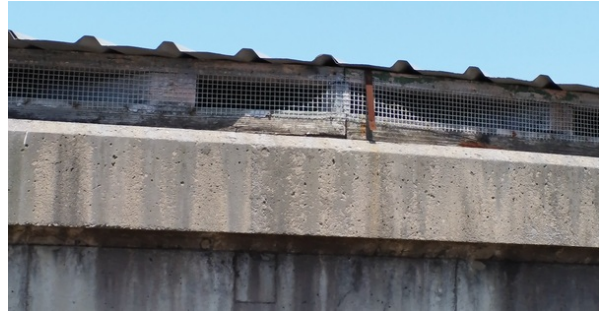
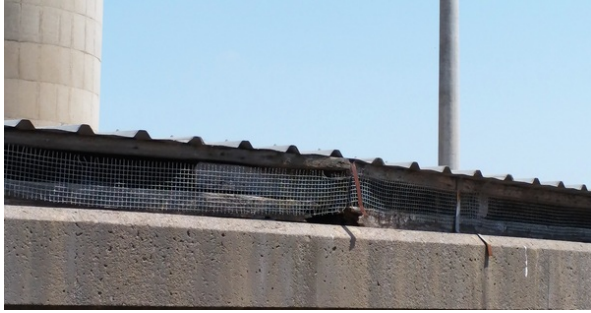
Ventilation condition

Very Poor Condition

Wooden bearers have deteriorated over time and warped around reservoir ventilation

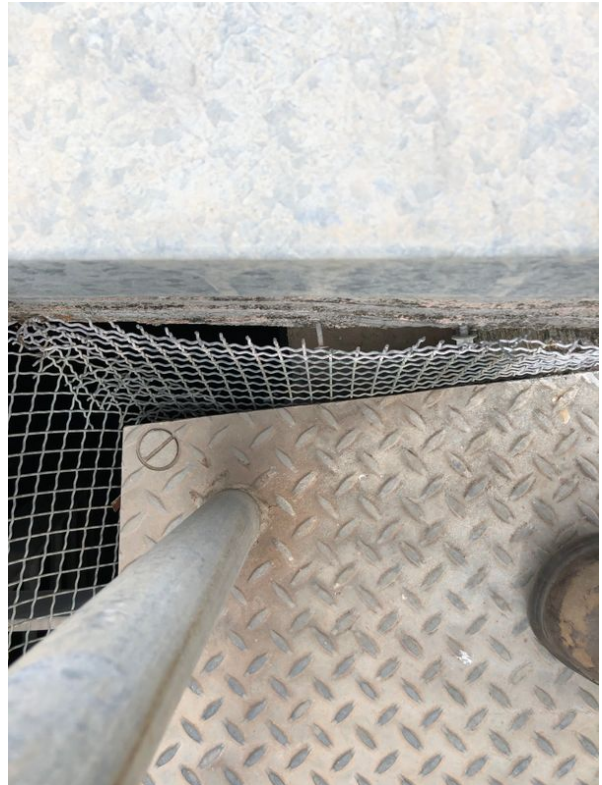
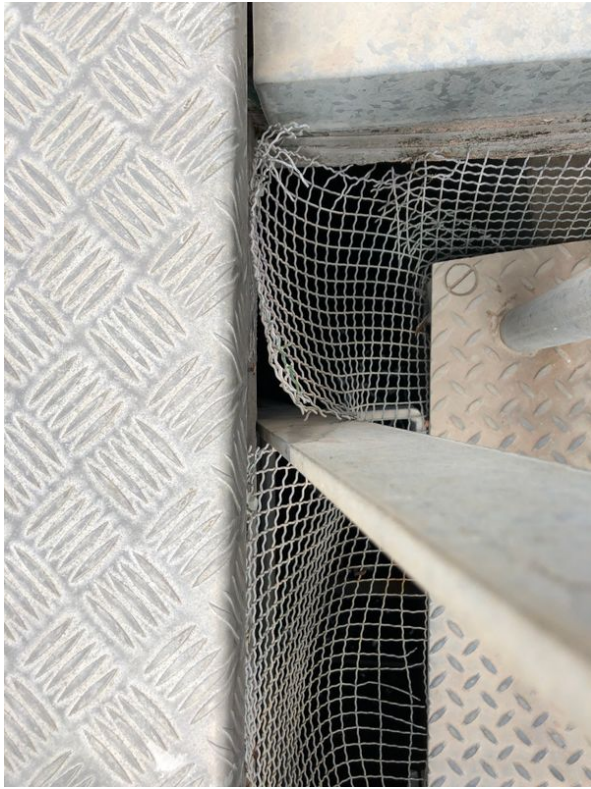
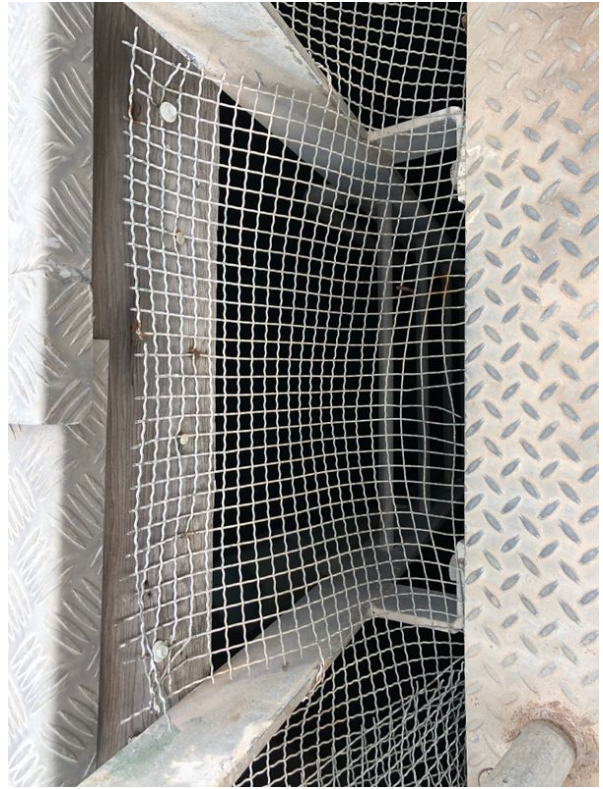
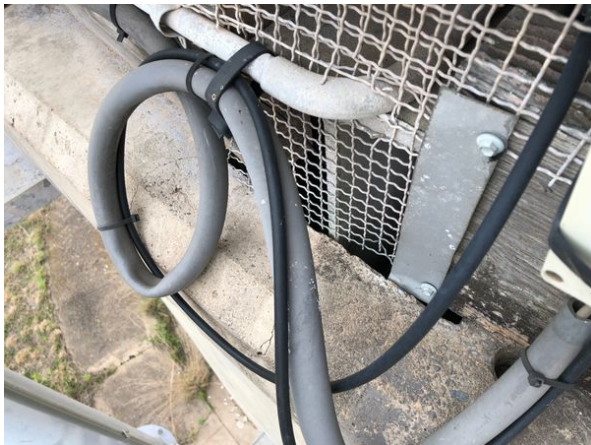
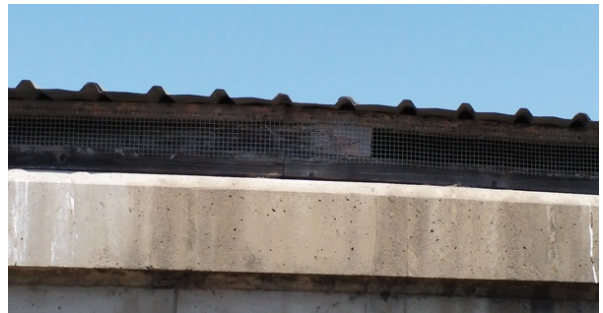
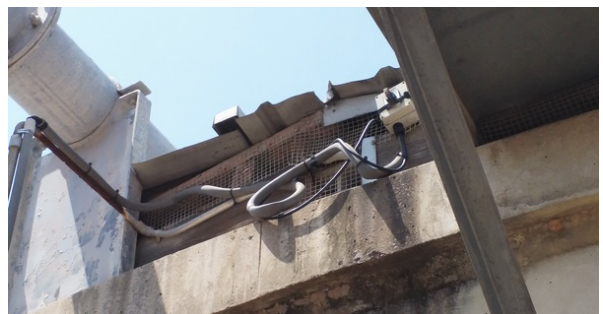
Vermin proofing condition

Very Poor Condition

Due to warping of wooden bearers, the vermin mesh is no longer effective. There are also gaps around the ladder area where the mesh has pulled away from the structure.

There is no sealing between the corrugations in the colourbond roof and the wooden bearers

What is the current gap (in millimetres)?

100

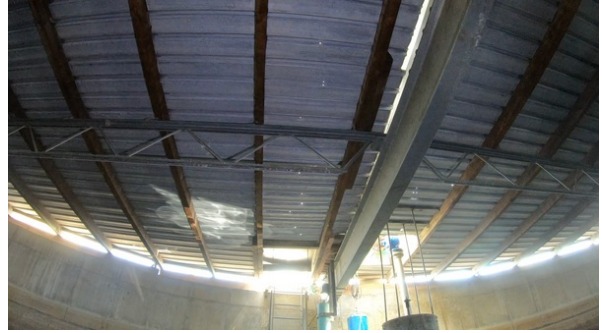
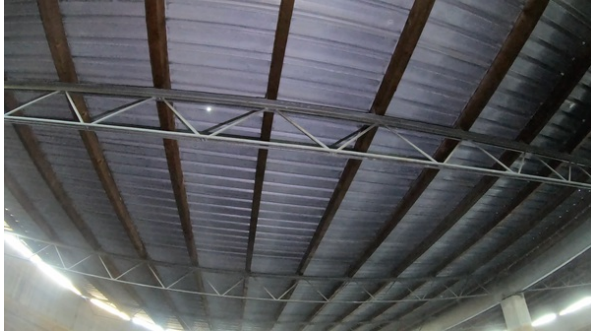
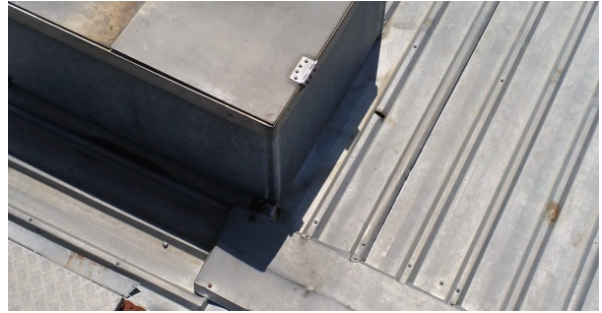
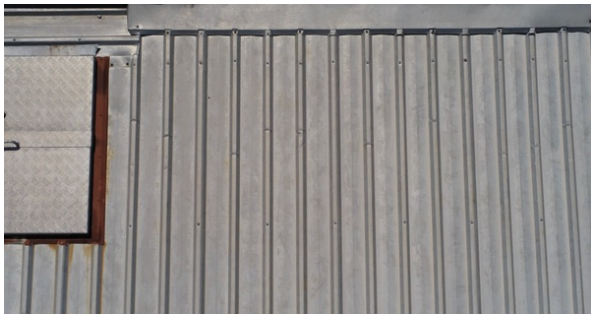
General roof condition

Fair Condition

There are multiple small holes in the roof which would allow water ingress into the reservoir

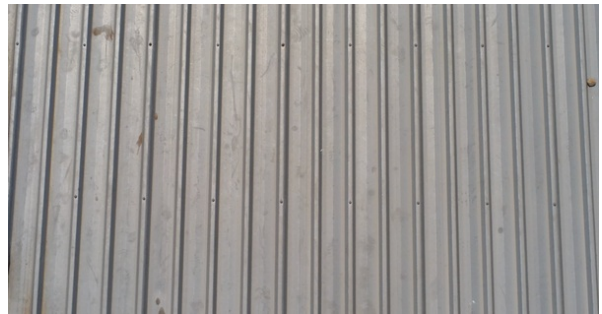
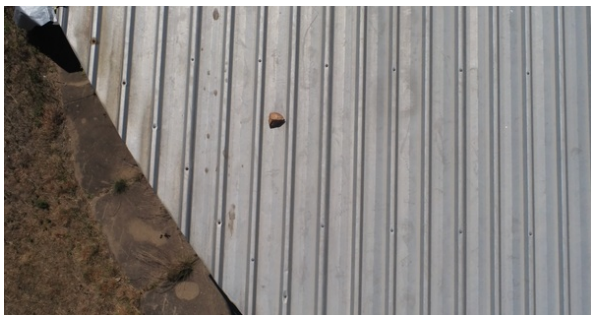
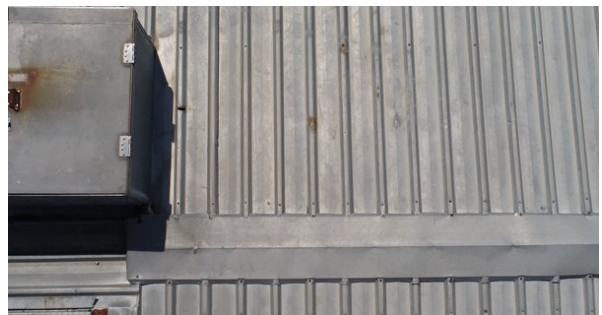
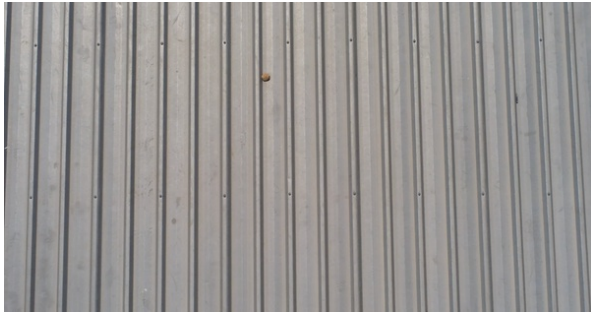
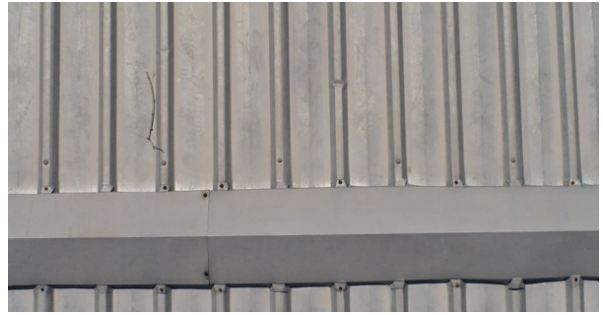
Is there debris on the roof?

Yes

What debris is present

screws, rivets, washers, rocks, stick, bird faeces

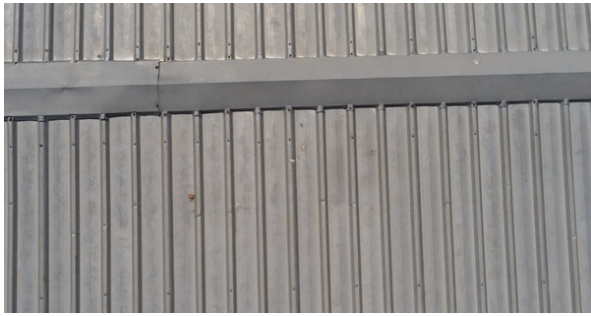
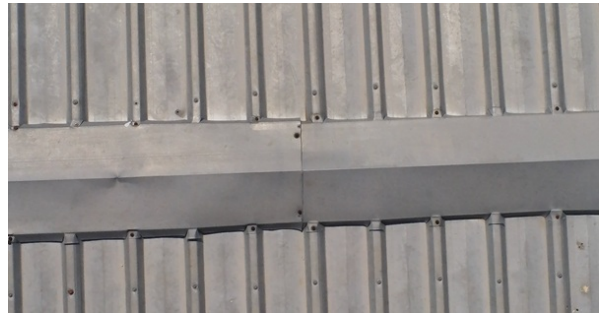
Are there missing screws/rivets?

Yes

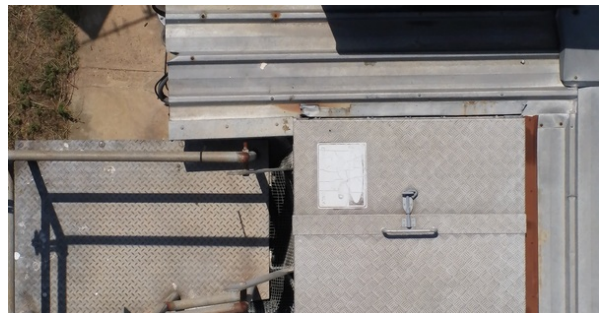
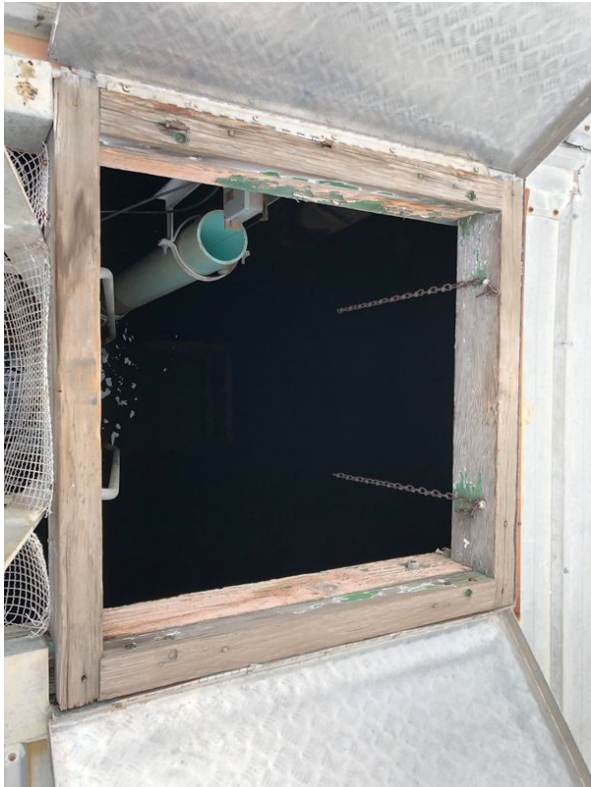
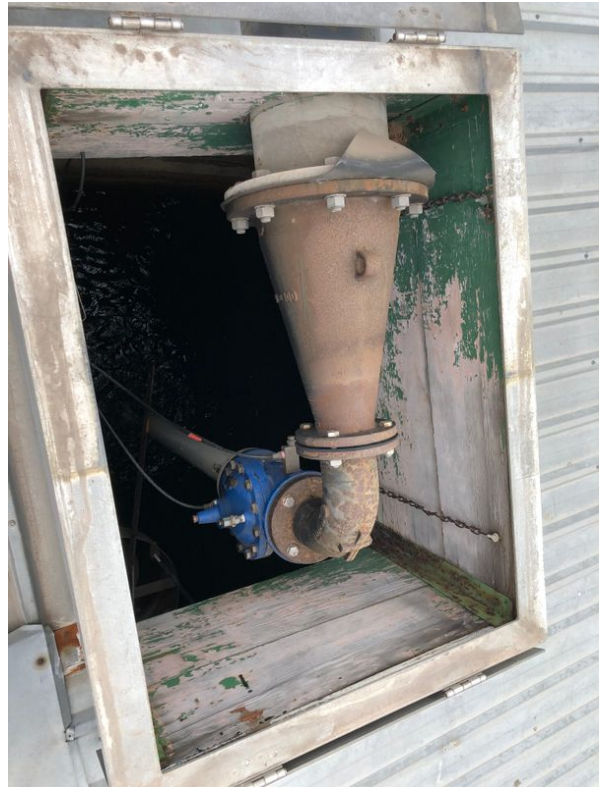
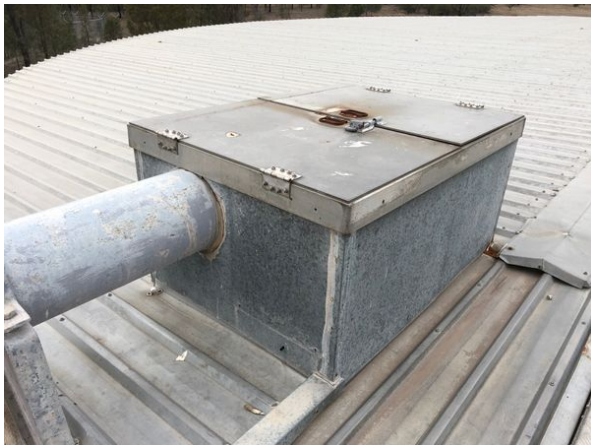
<p>Photo 31</p>	
What is the percentage of area with pooling?	1
Is there corrosion on roof sheets and gutters?	Yes
Are the roof penetration seals in good order?	No
<p>— Notes</p> <p>Hatches to inlet pipe and ladder without adequate seals to prevent water ingress during rain</p> <p>— Photos</p>

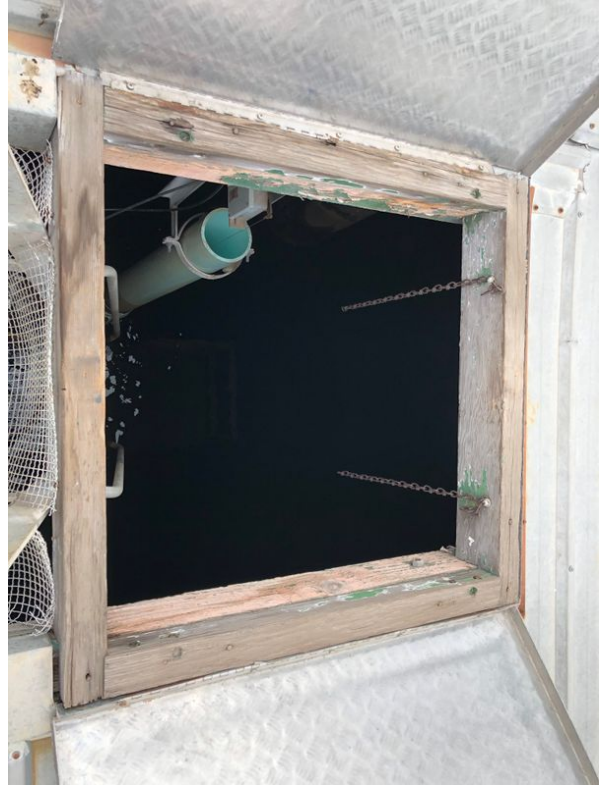
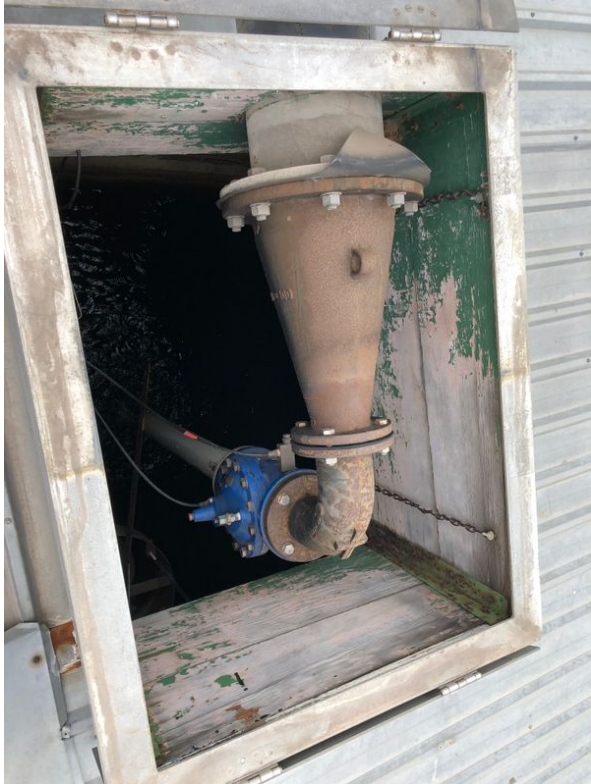
Entry hatch condition	Poor Condition
Do the hatches seal adequately	No

No seals present around hatches

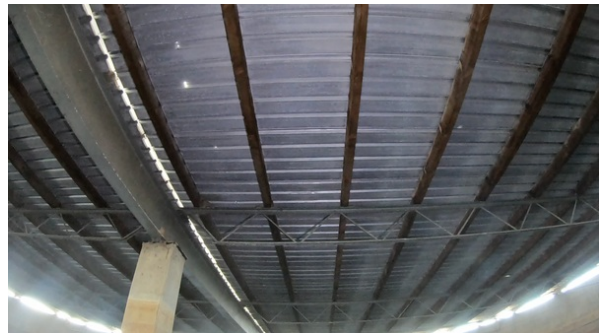
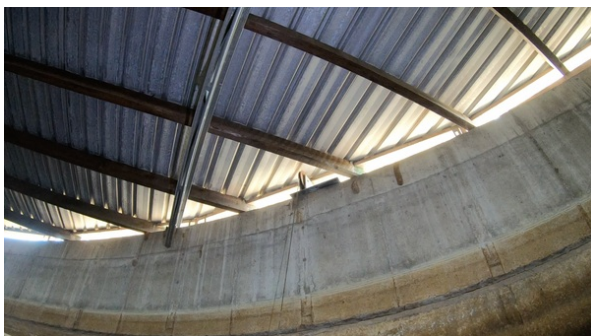
Internal Roof condition	Fair Condition
Are there any defects in the rafters?	Yes

Wooden rafters, evidence of rotting and warping (wood debris on reservoir floor)

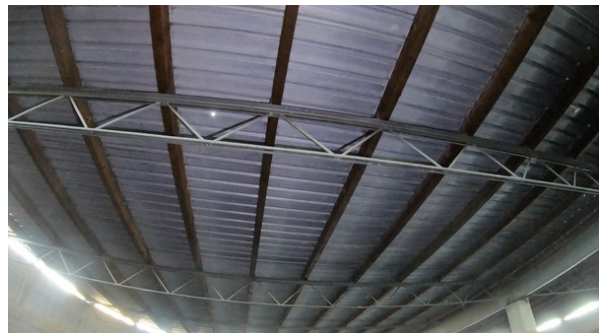
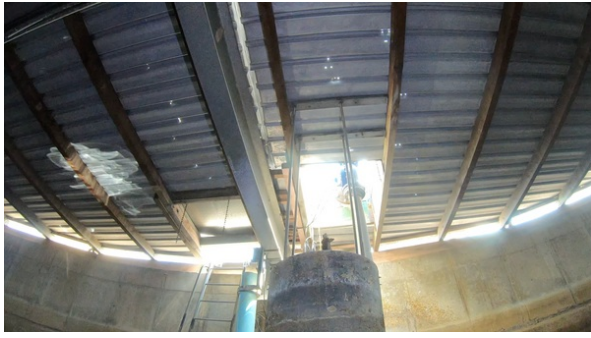
Any observed defects in roof?	Yes
– Notes Multiple small holes in roof sheeting	
– Photos <div>

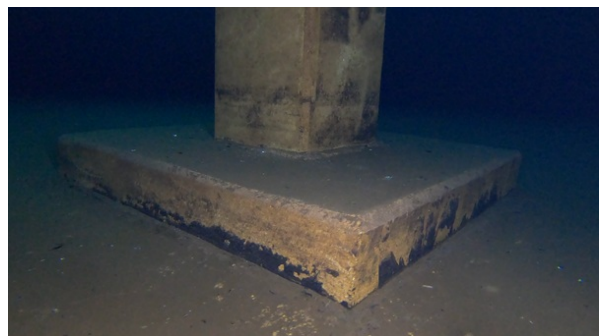
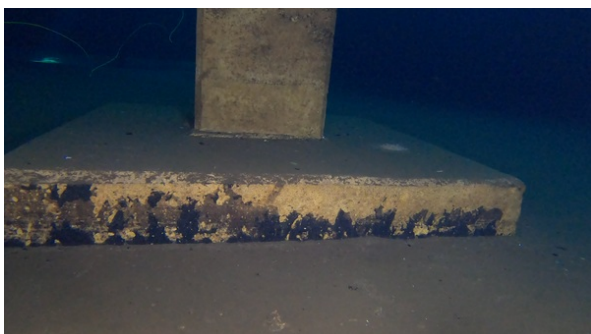
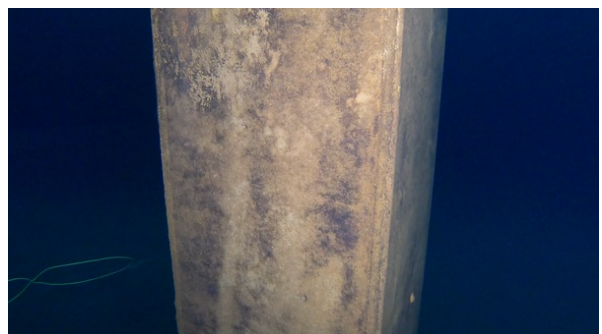
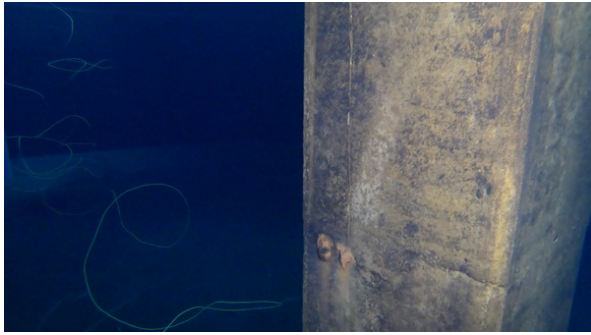
Column condition	Good Condition
<p>– Notes</p> <p>Observed crack in column approximately midway</p> <p>– Photos</p> <div>

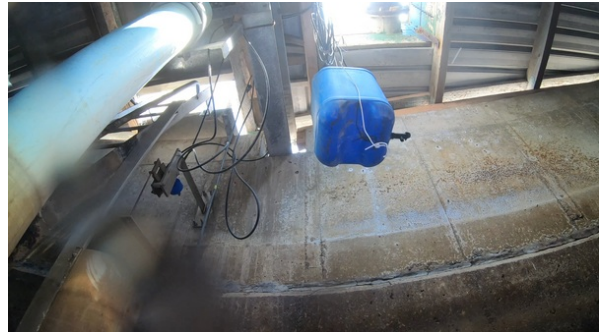
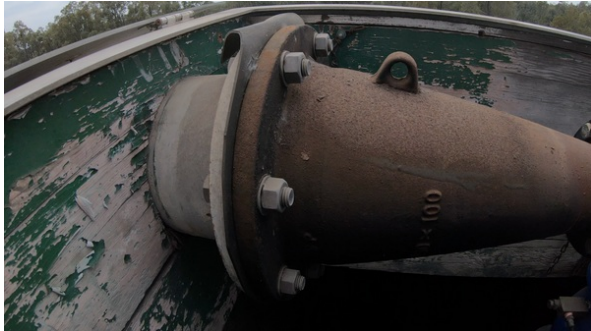
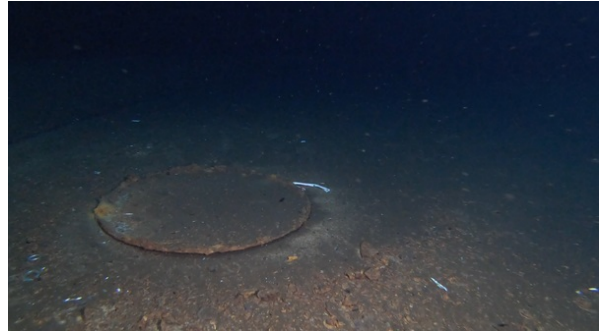
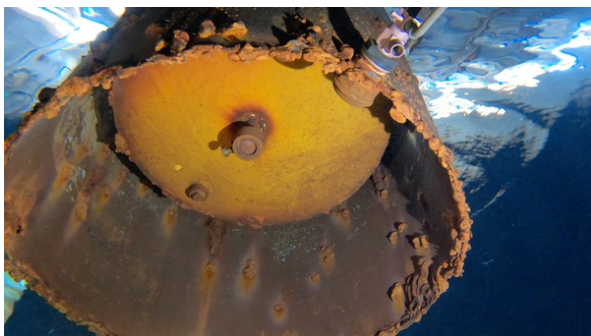
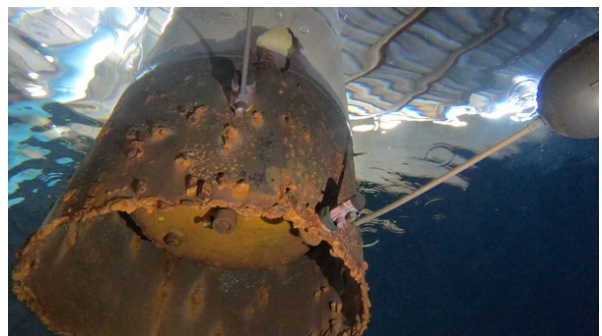
Inlet Condition

Fair Condition

Corrosion on inlet pipework, float switch mechanism corroded with base fallen off and sitting on tank floor

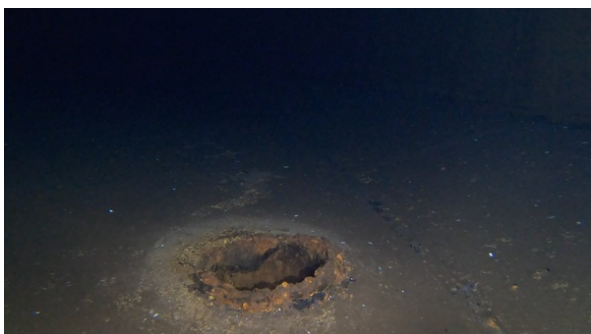
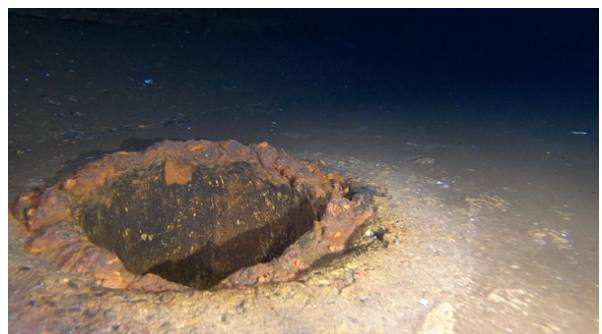
Outlet condition

Fair Condition

Corrosion around outlet

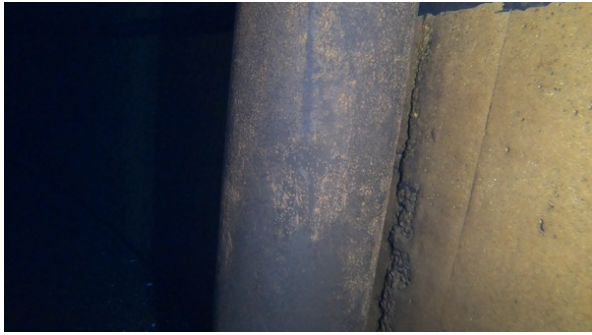
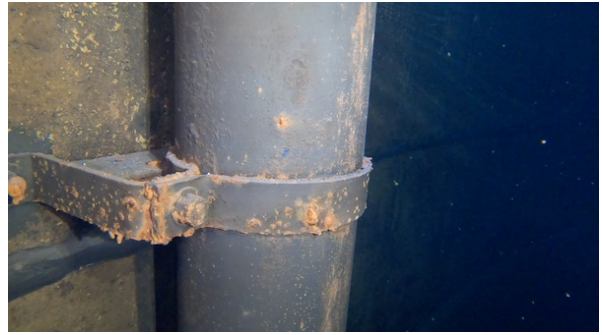
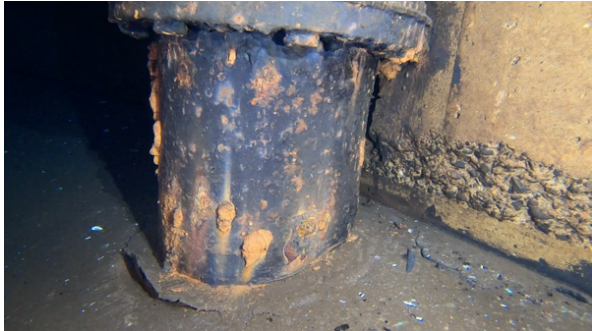
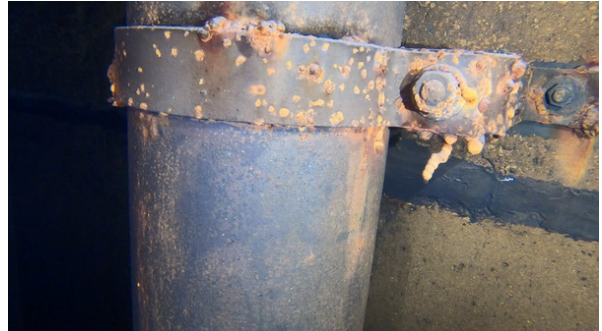
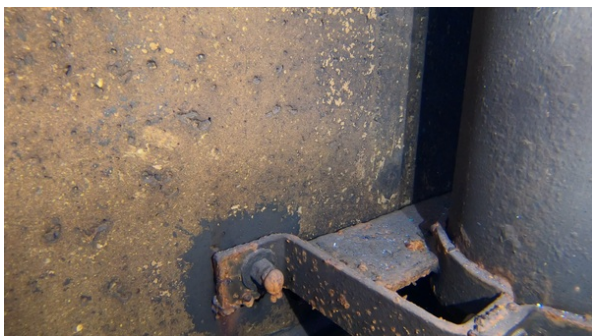
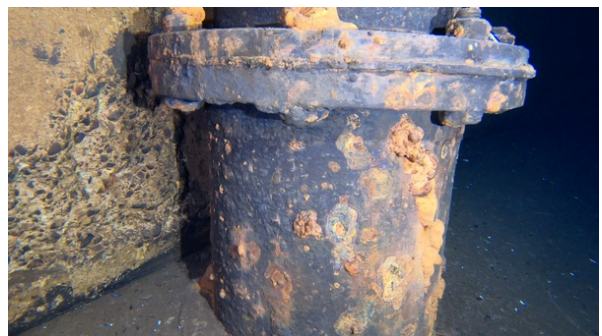
Overflow condition

Fair Condition

Average corrosion on overflow pipe, brackets holding pipe to wall also corroded however still functional

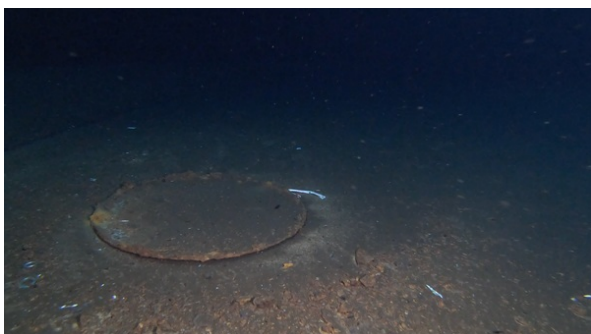
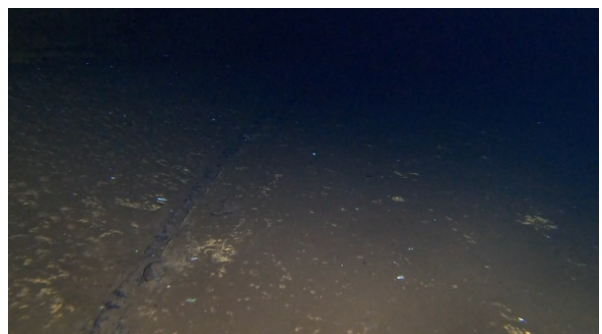
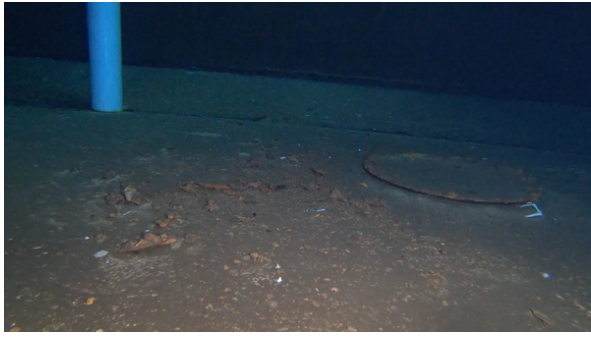
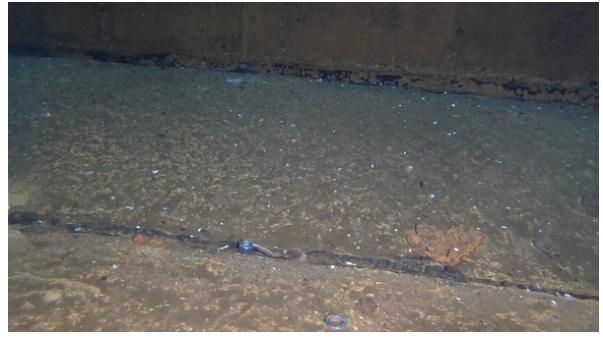
Debris	Yes
Type of debris	<div>+</div> Corrosion Pieces <div>+</div> Metal
<div>– Notes</div> <div>Wooden fragments from rafters</div> <div>Nuts</div> <div>Washers</div> <div>– Photos</div> <div>
