RES INSP 000001 /

/ 20 Nov 2019

Potable Water Reservoir Inspection

Reservoir Name

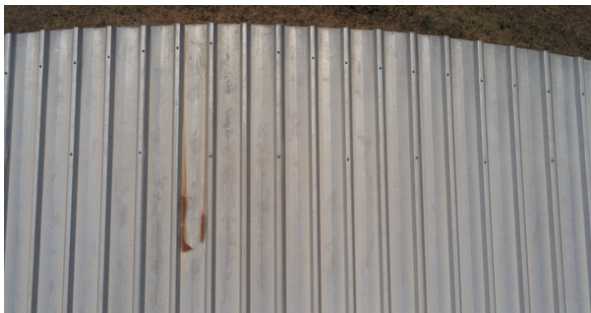
Photo 30

<p>Photo 31</p>	
What is the percentage of area with pooling?	1
Is there corrosion on roof sheets and gutters?	Yes
Are the roof penetration seals in good order?	No
<p>— Notes</p> <p>Hatches to inlet pipe and ladder without adequate seals to prevent water ingress during rain</p> <p>— Photos</p>

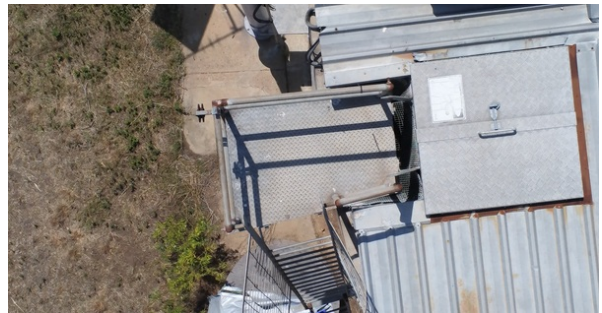
Photo 35

<p>Photo 32 Photo 33 Photo 34 Photo 35</p>	
Roof platforms & walkway condition	Good Condition
<p>— Photos</p>

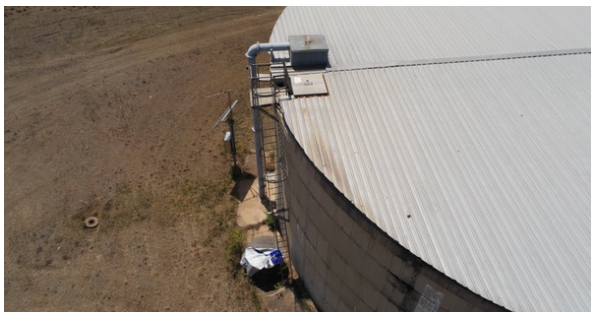
Photo 36

<p>Photo 36</p>	
Handrail condition	Good Condition
Davit / Fixed anchor point condition	N/A

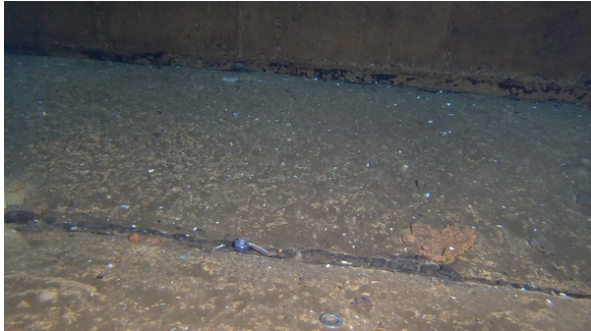
Floor condition	Good Condition
Any defects in internal seals	No
– Photos <div>     </div> <div> Photo 46 Photo 47 </div>	
Wall condition	Good Condition
– Photos <div>     </div> <div> Photo 48 Photo 49 </div>
